Amica North Shore
1157-1171 North Shore Boulevard
Burlington, ON, L7S 1C3

TREE INVENTORY & PRESERVATION PLAN

Date	Issued
August 2017	
Job Number	Drawn By
BTI-1398	SL
Scale	Checked By
As shown	TT
Sheet Number	File Number
TS.1

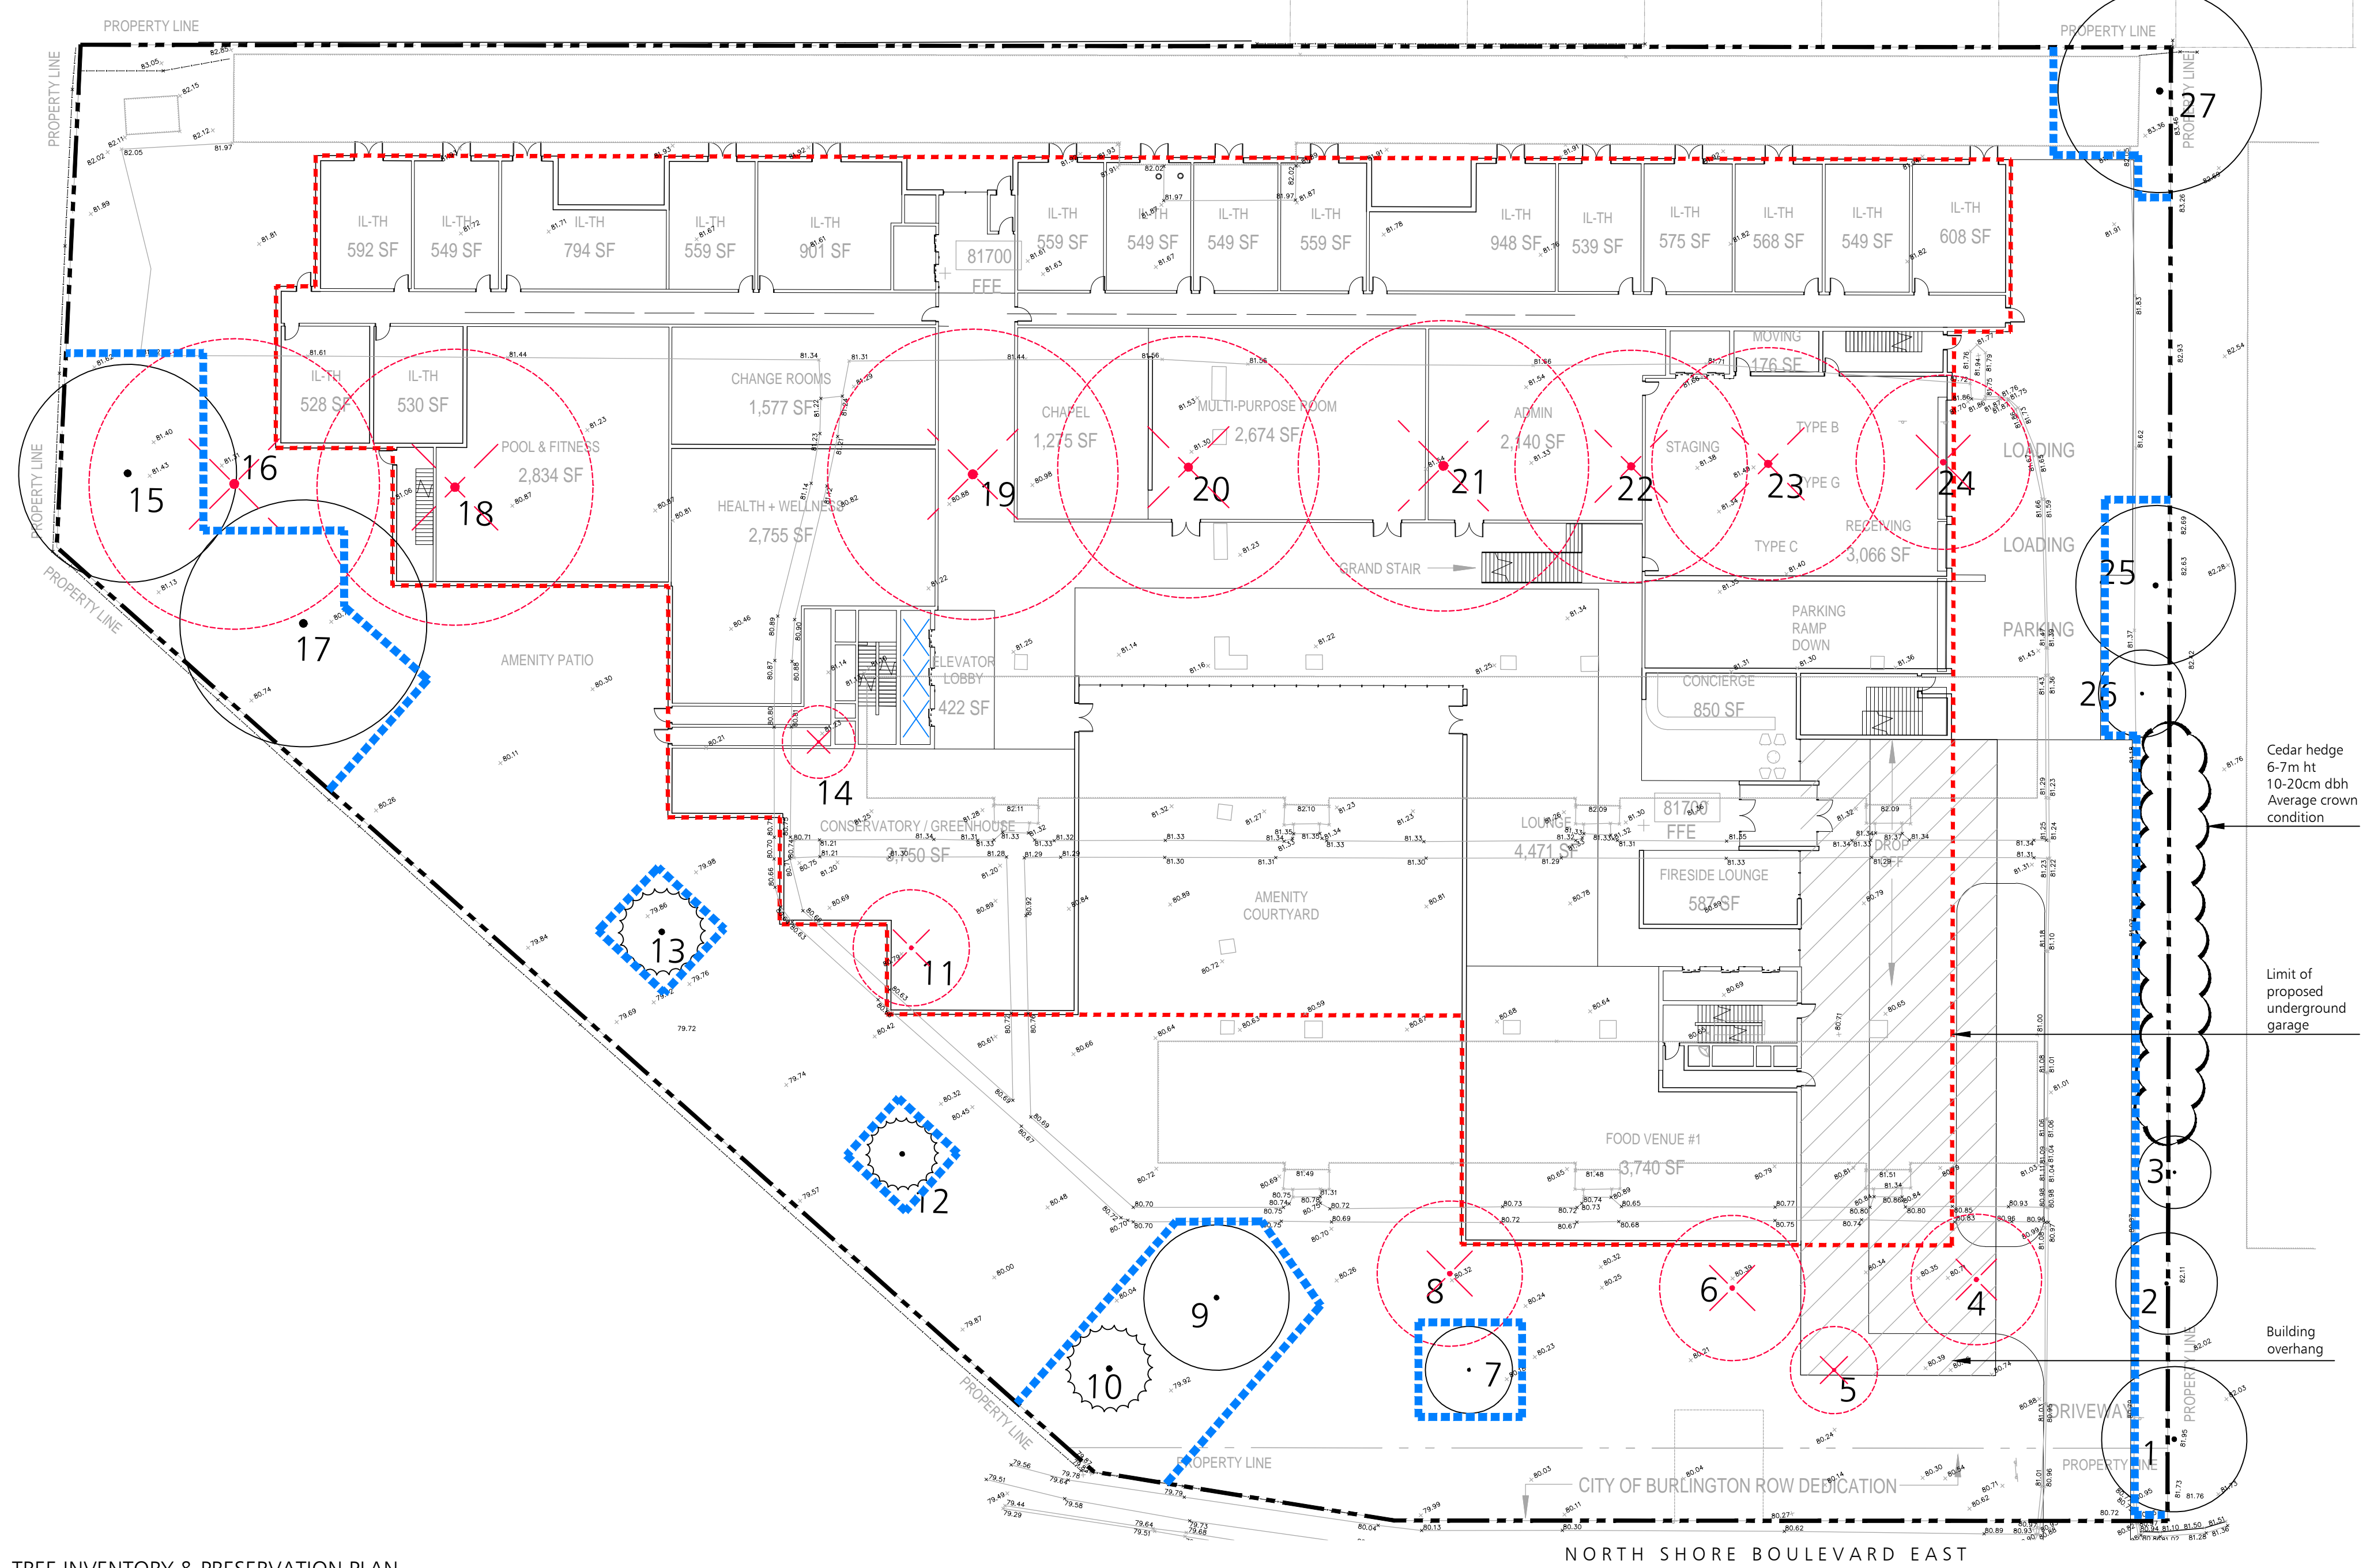
Tree No.	Species	dbh (cm)	Measure to Drip Line diameter (m)	Biological Health	Structural Condition	Recommended Action	Comments	Municipal Boulevard Subject Site	Location Boundary (5m to PL)
1	Juglans nigra	52	10	M	M	P	DB(M), BB, 2L	X	X
2	Acer saccharum	28	7	M	M	P	L20'W, DB(S), BB	X	X
3	Picea glauca	22	5	M	M	P	DB(M), BB	X	X
4	Betula papyrifera	19, 16, 24	9	M	M	RC	3L, DB(S), BB	X	X
5	Picea pungens	37	7	H	H	RC	PL	X	X
6	Gleditsia triacanthos	34	10	MH	H	RC	PL, DB(S)	X	X
7	Picea pungens	46	6	MH	H	P	PL, DB(S)	X	X
8	Gleditsia triacanthos	35	10	MH	H	RC	PL, DB(S)	X	X
9	Gleditsia triacanthos	38	10	MH	H	P	PL, DB(S)	X	X
10	Picea pungens	35	6	H	H	P	PL, 2L	X	X
11	Betula papyrifera	23, 17, 22	8	M	M	RC	3L, DB(S), BB	X	X
12	Betula papyrifera	28	5	H	H	P	PL, DB(S)	X	X
13	Picea pungens	43	6	H	H	P	PL, DB(S)	X	X
14	Picea pungens	45	5	MH	H	RC	Top dead, PL, DB(S)	X	X
15	Acer saccharum	84	15	MH	M	P	DB(S), BB	X	X
16	Salix sp.	114	20	M	M	RC	BB, DB(M), WS, TD(rot-healed)	X	X

17	Platanus x acerifolia	78	17	MH	MH	P	UB(S), DB(S), BB, PL	X	X
18	Platanus x acerifolia	90	19	M	M	RC	TD(rot-healed), PL	X	X
19	Platanus x acerifolia	133	20	MH	MH	RC	DB(S), BB, 2L, IB, PL, WS	X	X
20	Platanus x acerifolia	95	18	MH	MH	RC	DB(S), BB	X	X
21	Acer saccharum	109	20	M	M	RC	PL, DB(S), BB	X	X
22	Platanus x acerifolia	54	16	H	H	RC	DB(S)	X	X
23	Platanus x acerifolia	67	16	H	H	RC	DB(S)	X	X
24	Juglans nigra	52	12	M	M	RC	L10'E, DB(M), BB	X	X
25	Juglans nigra	38	11	M	M	P	DB(M), BB	X	X
26	Juglans nigra	22	6	M	M	P	UB(W)	X	X
27	Acer negundo	42	14	M	M	P	UB(S), L45'S, DB(M), BB	X	X

- Install hoarding for subsequent municipal review/approval.
- Hoarding may be moved temporarily to provide access for tree removal only. These trees should be felled away from protected areas to avoid pulling and breaking of roots of trees to remain.

- Pruning, if required, should be done prior to construction and in accordance with current arboricultural practices.
- Storage of any materials, fill, vehicles/equipment, and disposal of liquids is not permitted within 1m of protected areas.

- Excavation in close proximity to protected areas are to be undertaken with a certified arborist present.
- Roots encountered due to excavation are to be cut with a clean sharp blade. Tearing and ripping of roots is not permitted.

- Hydrovac is recommended as the preferred method for excavation, within 1m of protected areas.
- Exposed roots are to be covered immediately with mulch or topsoil and watered thoroughly. A light coloured tarpaulin may also be used to prevent root desiccation.

- Deep root fertilize (3:1:1) following backfilling.
- Trees should be re-assessed periodically in order to maintain an up to date understanding of health and structure.
