Phase One Environmental Site Assessment

1157-1171 North Shore Boulevard
Burlington, Ontario

September 13, 2018

Pinchin File: 212394

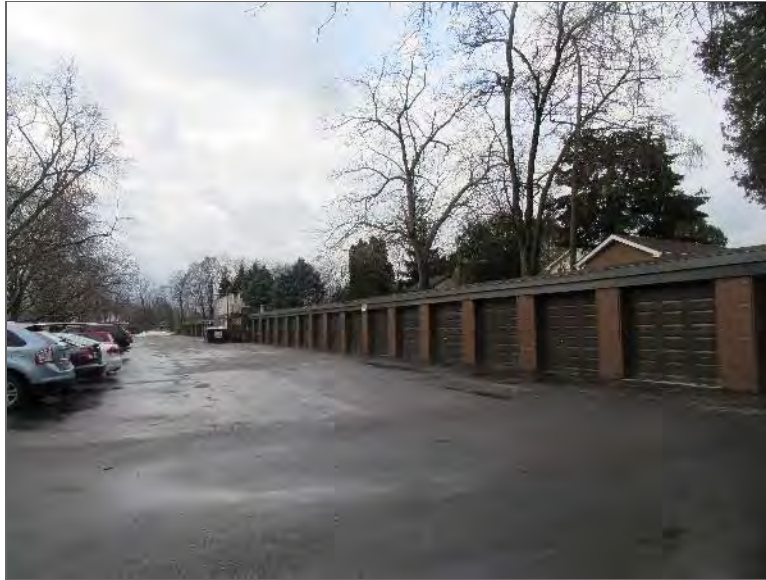
Photo 5 – General exterior view of Site Building C (east elevation looking west).

During the Site reconnaissance, Pinchin observed three buildings/structures on the Phase One Property. The buildings consisted of two (2) four-storey multi-tenant residential buildings (Site Buildings A and B) and one single-storey automotive parking/storage structure with a boiler room that was partially below grade (Site Building C), constructed circa 1948.

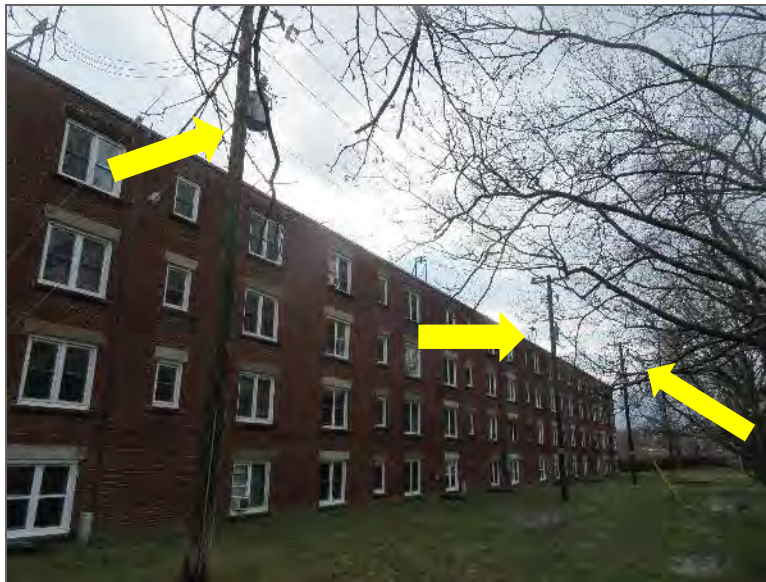
Photo 7 – General view of three pole-mounted transformers located on the central and northeast-central portion of the Phase One Property.

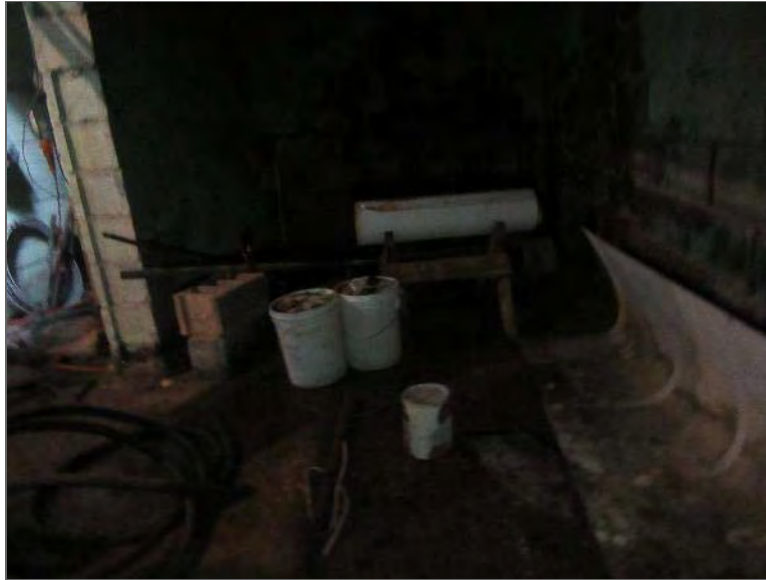
Photo 8 – Former coal storage area, located in the basement located within Site Building C.

During the Site reconnaissance, Pinchin observed one natural gas-fired boiler that provided hot-water heating to radiators throughout Site Buildings A and B. As noted in Section 5.0, the former heating system at the Site was coal-fired and the coal was formerly stored within the boiler room. The former coal storage area was removed and replaced by a natural gas-fired boiler circa 1960s.

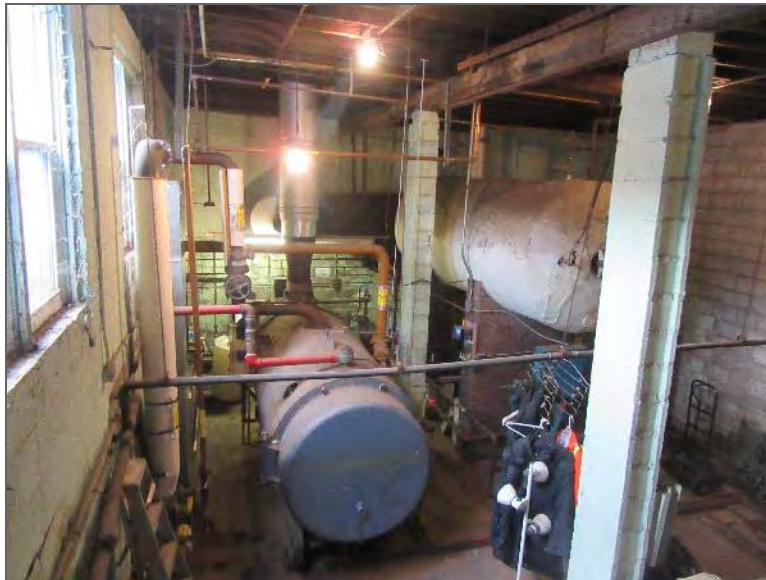
Photo 9 – Representative view of the boiler room located within Site Building C.

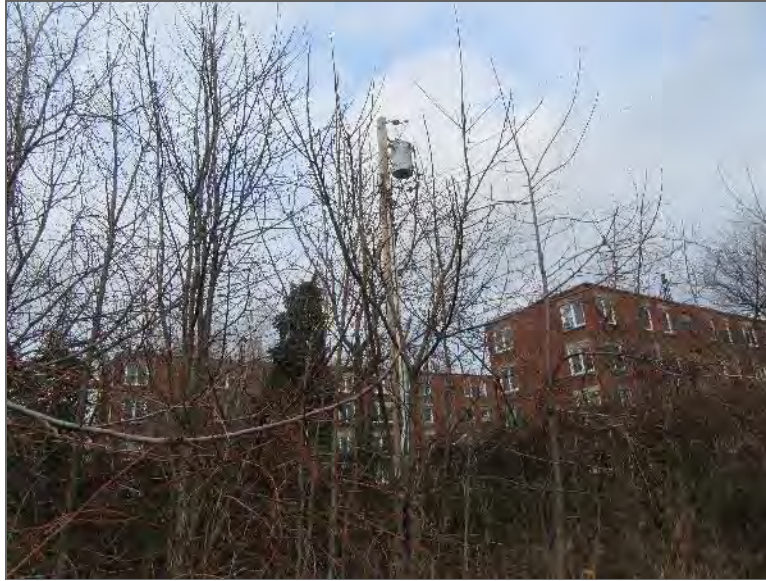
Photo 10 – Pole-mounted transformer located immediately southeast of the Phase One Property.
